# Odessa Disturbance Events May 2021 & June 2022

Patrick Gravois  
Operations Engineer – Operations Analysis

ESIG Webinar  
November 3, 2022

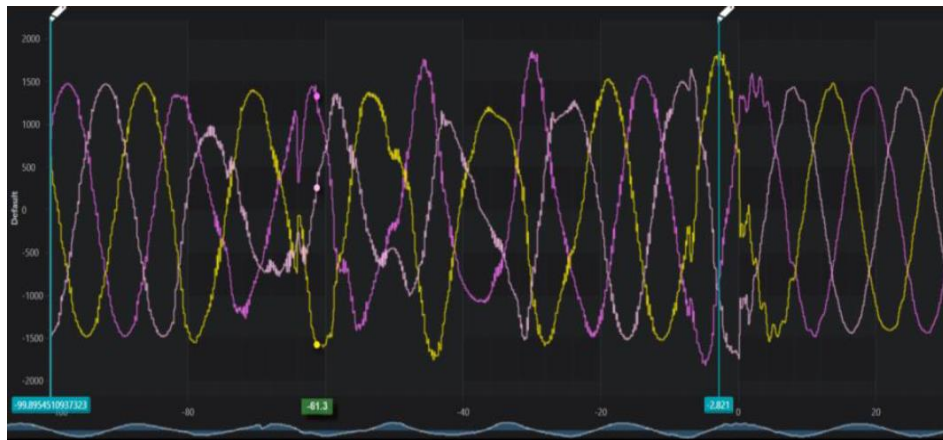
- Two solar facilities – reductions of 205 MW and 64 MW
- POI high resolution data shows voltage within PRC-024-3 and ERCOT NOG voltage “no trip” curve (<1.2 pu)
- Inverter experiences spikes (instantaneous peak) above 1.3 pu at terminals
- OEM states overvoltage settings cannot be modified for any existing facilities due to inverter protection
- AC overvoltage tripping for this OEM will likely continue to occur in future
- Identified in nearly all solar PV disturbances analyzed by NERC
- Potential corrective action is to reduce k-factor of DVC within inverter to reduce reactive injection
- Both facilities performed PSCAD studies on reduced k-factor and saw improvement

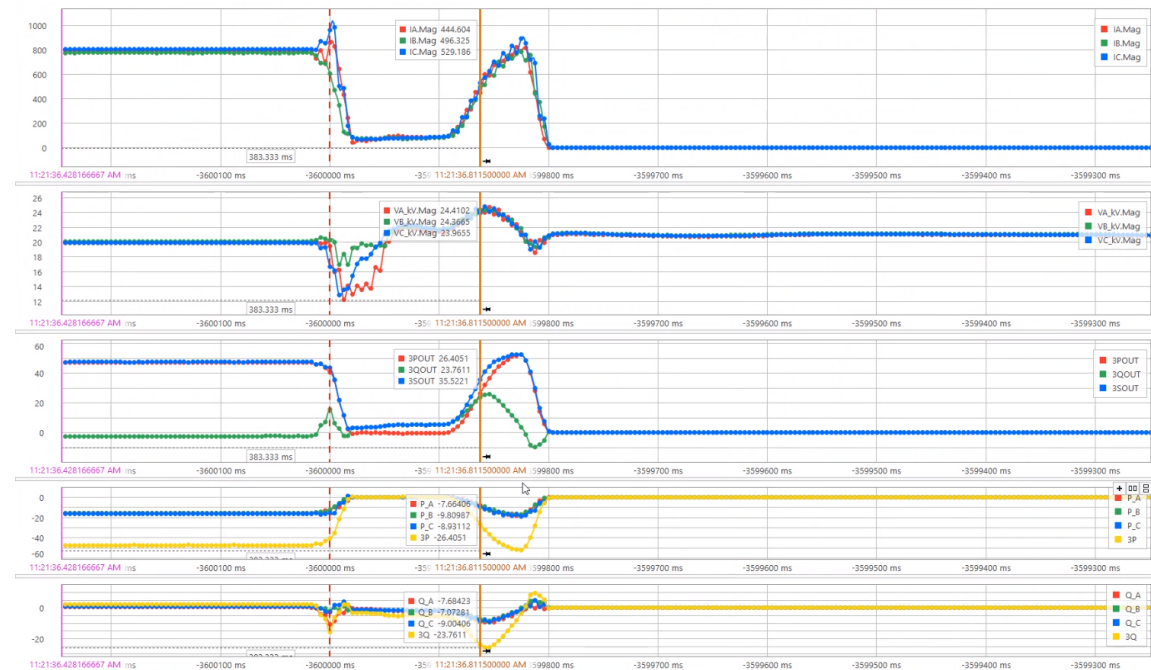
- Voltage driven high by reactive current injection after fault cleared and voltage recovered
- All feeder protection at one facility set to trip on instantaneous phase ac overvoltage
- Set at 1.2 pu – directly on PRC-024-3 and ERCOT NOG VRT curves
- Review team questioned need for this feeder-level protection
- Plant personnel unable to clarify what the voltage protection was protecting at the feeder level
- Plant has since disabled feeder level overvoltage protection – concern that inverter protection could trip for similar event

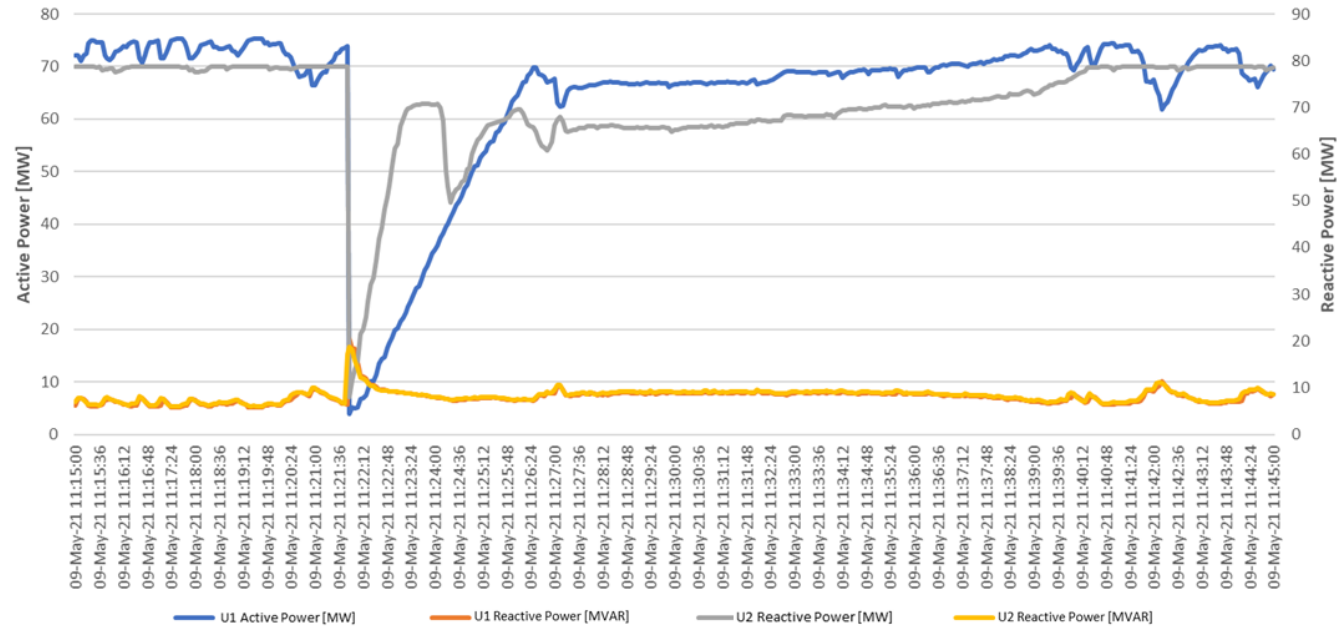
- Legacy inverters at one plant – momentary cessation below 0.9 pu voltage
- Inverters should recover to predisturbance output relatively quickly (<1 sec) when voltage recovers
- Plant-level controller interactions – slowed recovery to BA ramp rate limits
- Not appropriate use of these limits; negatively impacting system stability
- Not meeting recommended performance in NERC reliability guidelines
- Plant has replaced PPC since 2021 Odessa event to improve recovery time

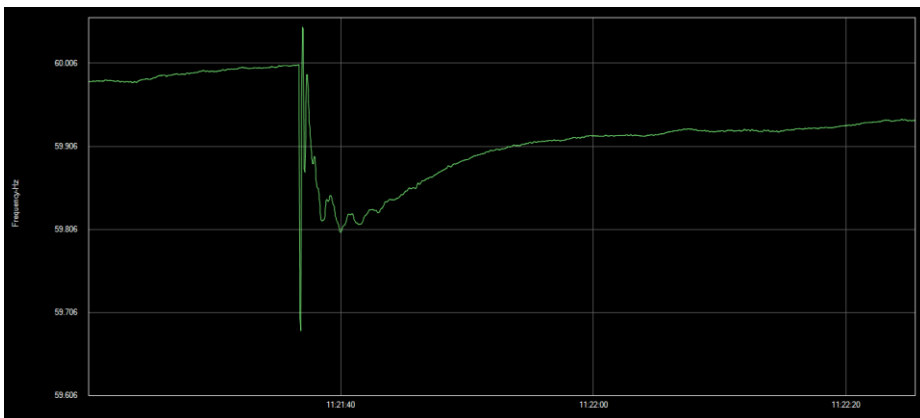
- Inverter-Level Underfrequency:
  - One facility had all inverters trip on “grid underfrequency” below 58.2 Hz
  - Grid frequency did not fall outside of the PRC-024-3 boundaries – low frequency of 59.8 Hz
  - Inverters likely erroneously tripped on a poorly measured or calculated frequency signal during fault conditions
  - Facility modified settings but not until after Odessa 2022
- Feeder-Level Underfrequency:
  - One feeder-level relay operated on frequency below 57.5 Hz
  - NERC followed up with relay OEM to perform root cause analysis
  - Newer relay version used at this facility, set with very fast measurement window
  - Relay OEM modifying adjustable window to eliminate problem – at least 5-cycle measurement window
  - Facility has modified settings but not until after Odessa 2022

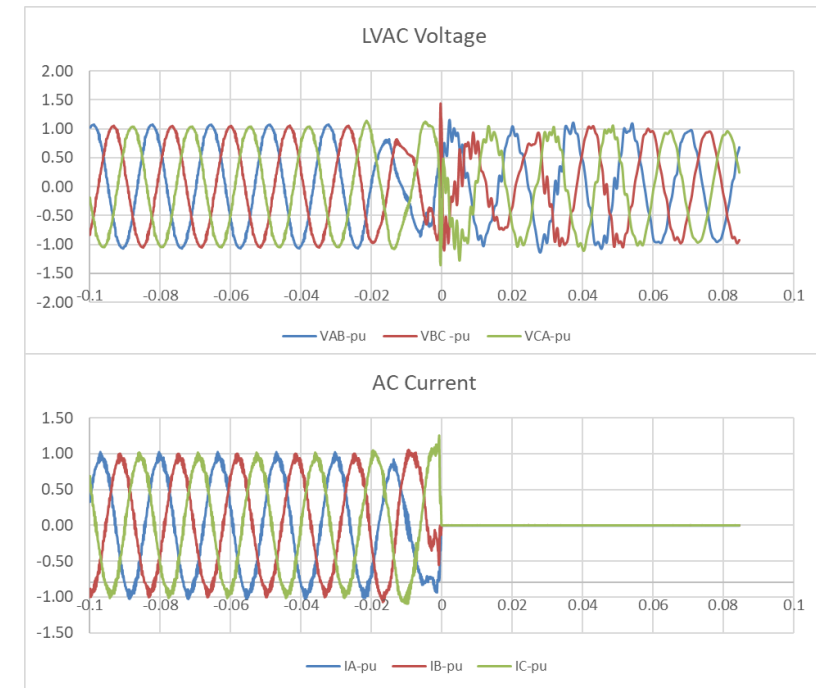
- **2 plants with OEM1 inverters (259 and 176 MW loss)**
  - Both plants in commissioning during 2021 Odessa
  - All inverters tripped on either AC Overcurrent Low (140% of rated current) or High (150% of rated current)
  - Overcurrent caused by distorted voltages and instantaneous current spikes during fault conditions
  - Protection prevents damage to insulated-gate bipolar transistors within inverter – cannot be increased
  - OEM developed and currently testing potential upgrade to prevent overcurrent during this type of event
- **1 plant with OEM3 inverters (10 MW loss)**
  - 7 of 79 inverters tripped – OEM out of business and unable to provide analysis/corrective actions

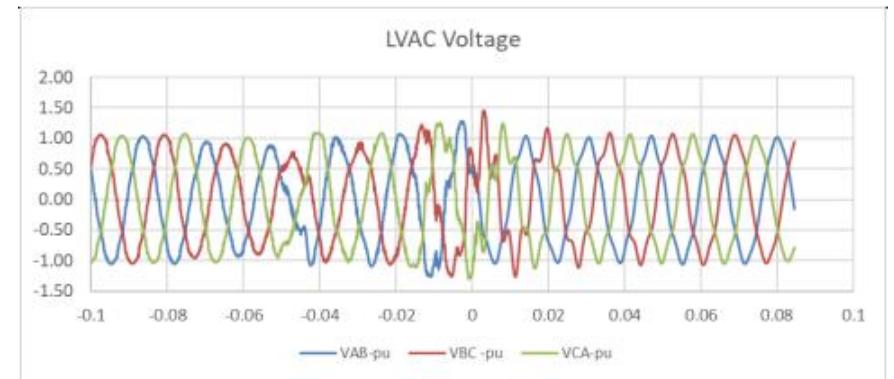
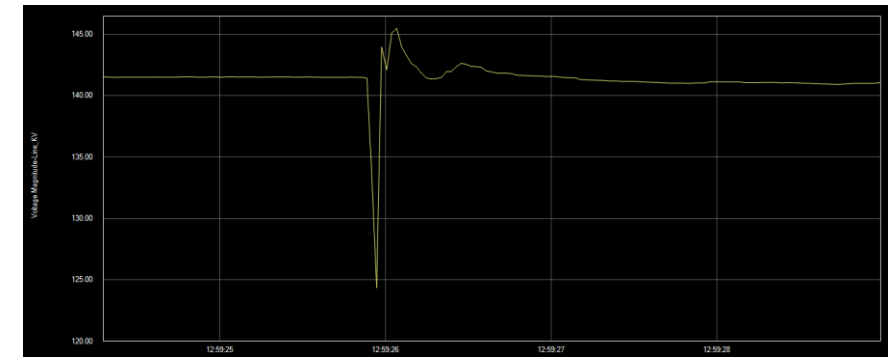
- Had feeder breaker trip on underfrequency during 2021 Odessa event
- All inverters tripped on Instant AC Overvoltage in which inverter trip occurs in 1-3 ms when voltage exceeds 1.25pu
- Inverter terminal voltage reached > 1.3pu during event, but high side of GSU only reached 1.056 pu per PMU data provided by RE – likely caused by reactive injection once fault has cleared
- Plant had two feeder breakers trip on underfrequency < 57.5 Hz; have adjusted breaker underfrequency settings since event
- OEM has identified potential solutions – increasing fast overvoltage protection to 1.4 pu and reducing k-factor to reduce reactive injection causing high voltage at inverter terminals

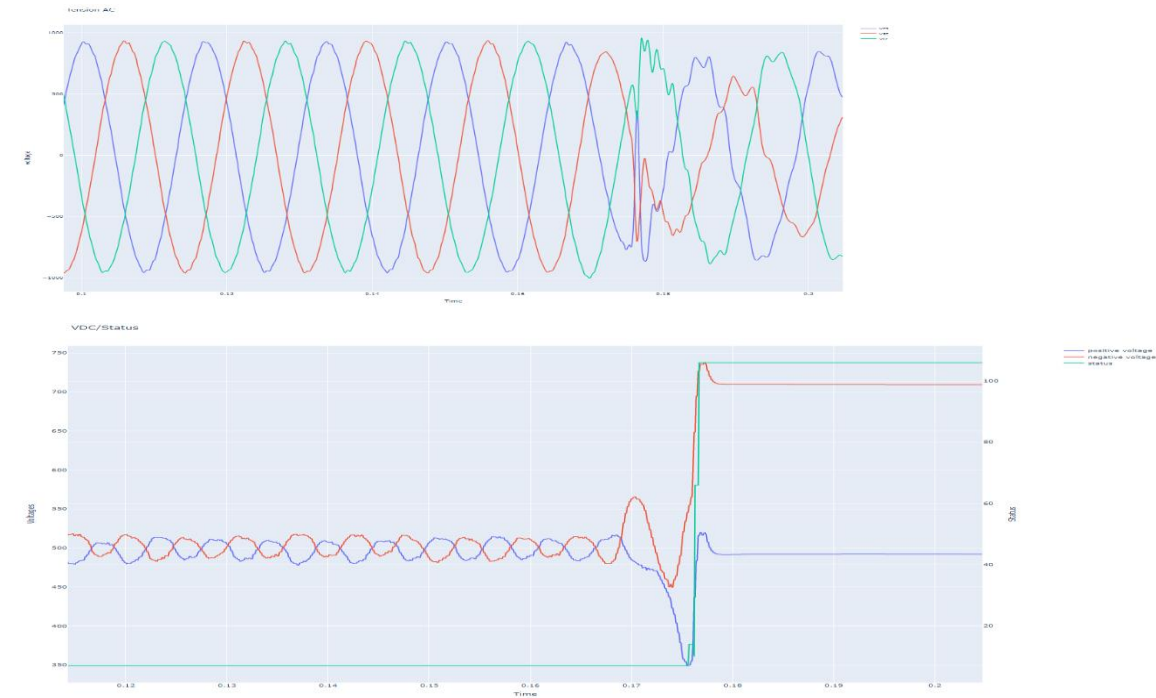
- **2 plants with OEM2 inverters (neither plant involved in 2021 Odessa event)**
  - Fault Code for Vdc Unbalance occurs when DC-side positive and negative bus voltage differ by  $> 100$  V (minor) or  $> 200$  V (major) for 1 ms
  - AC voltage phase became unbalanced faster than controls could regulate DC-side due to disturbance
  - Plants and OEM claim protection operated correctly and required for equipment protection – potential DC short
  - Issue seen in previous events and OEM was already working on fix
  - Software update currently available to improve DC regulation response time and ride-through capabilities
  - One plant has already implemented software upgrade; Second plant scheduled in November

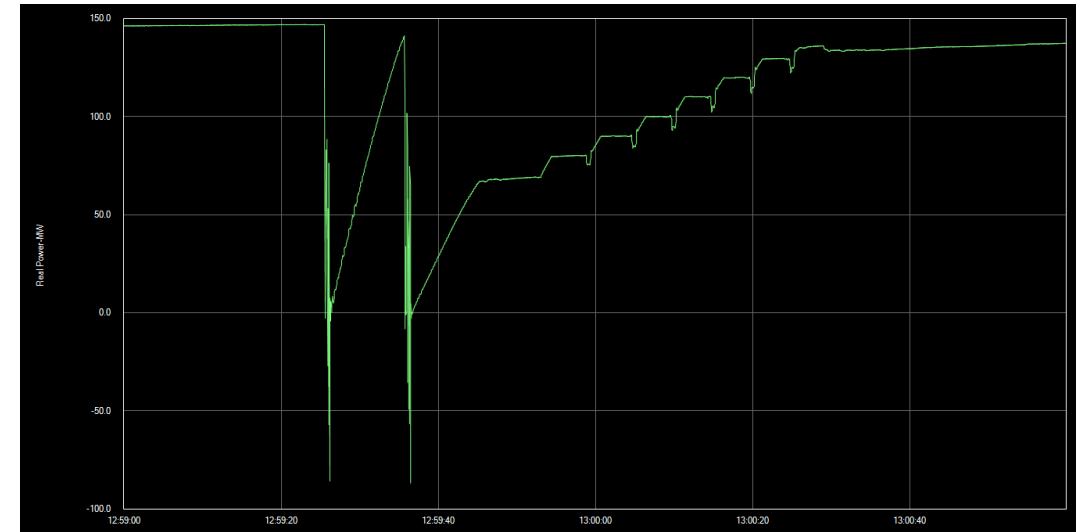
- **1 plant with OEM2 inverters**
  - Provides 100% reactive current during LVRT and did not recover quickly (~10 sec) upon fault clearing
  - Issue identified during Odessa 2021 event analysis but primary cause during 2021 event was feeder breaker tripping on underfrequency (since disabled)
  - Plant has adjusting settings to:
    - Change LVRT/HVRT mode to provide consistent active power as well as required reactive power
    - Change fast overvoltage protection trip settings to 1.35pu with 0.5 sec delay
  - LVRT mode disabled during 2022 event – caused slow response due to PPC interactions
  - LVRT now enabled and all inverter setting changes complete
  - PSCAD modeling required to determine cause of oscillations

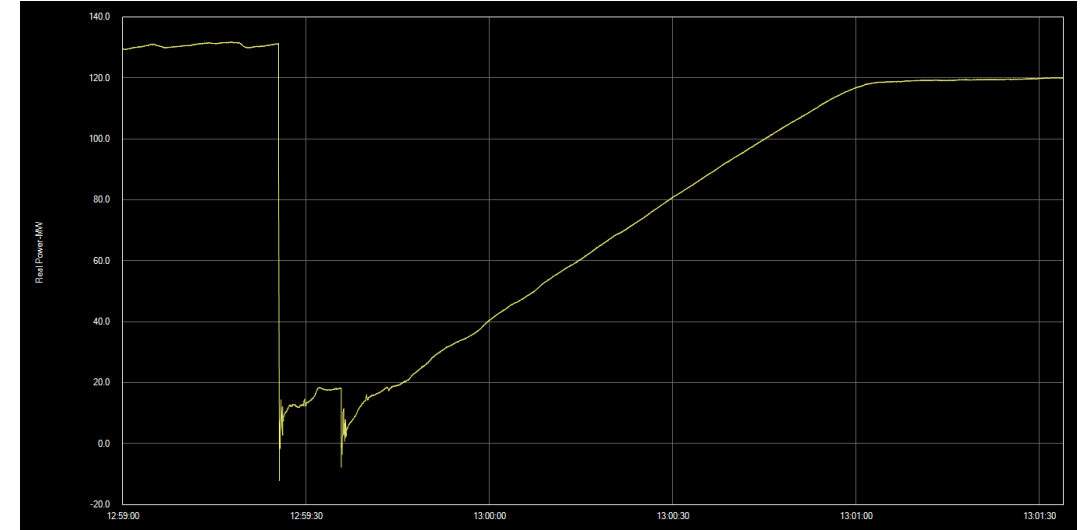
- **1 plant with OEM2 inverters**

- Previously thought momentary cessation could not be disabled but discovered it was disabled during 2022 event
- Inverters reduced output due to loss of auxiliary power during 2022 event
- Legacy inverters with limiting logging capabilities – difficult to identify corrective actions to improve response
- Unclear whether voltage drop or phase jump caused initial active power loss
- One potential corrective action is to install UPS for each inverter – unclear if this would allow inverters to ride-through large phase jump
- Momentary cessation reenabled to allow quicker return after fault clearing – cannot provide reactive
- Potentially may not be able to meet current VRT requirements with current inverters
