# Odessa Disturbance Events May 2021 & June 2022

Patrick Gravois  
Operations Engineer – Operations Analysis

ESIG Webinar  
November 3, 2022

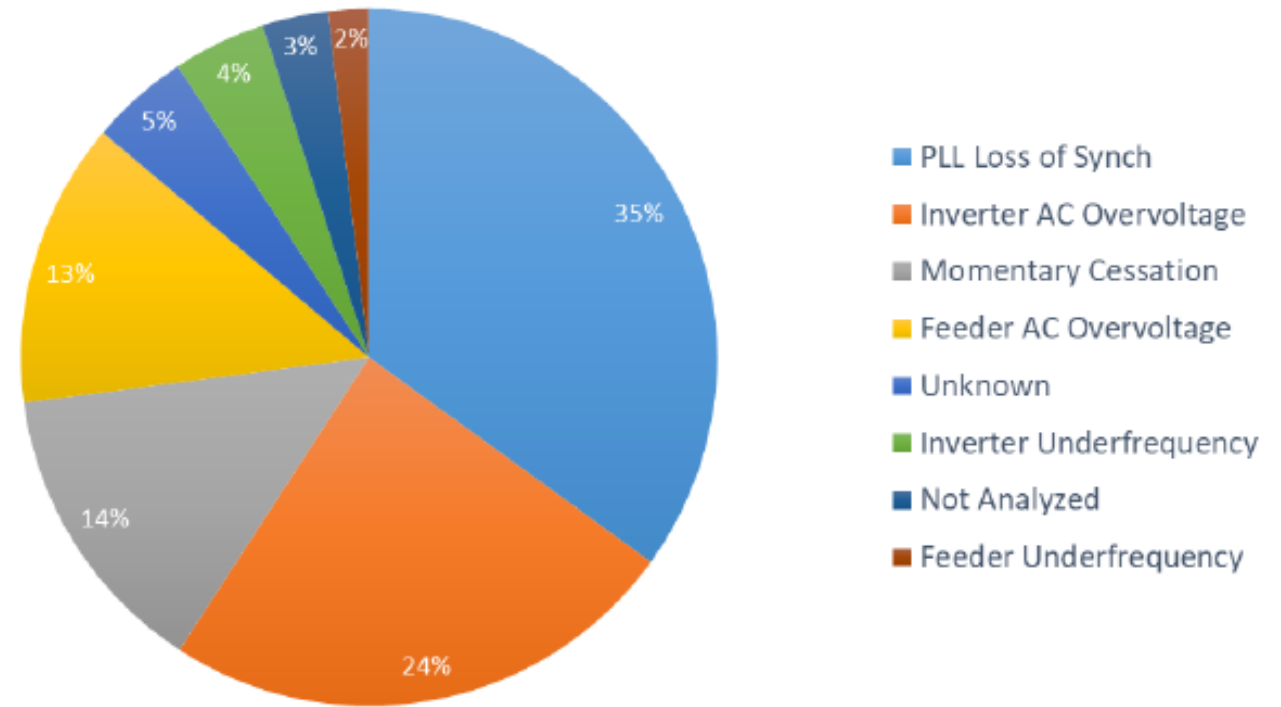
# Causes of Solar PV Reduction – 2021 Odessa

Table 1.1: Causes of Reduction	
Cause of Reduction	Reduction [MW]
PLL Loss of Synchronism	389
Inverter AC Overvoltage	269
Momentary Cessation	153
Feeder AC Overvoltage	147
Unknown	51
Inverter Underfrequency	48
Not Analyzed	34
Feeder Underfrequency	21

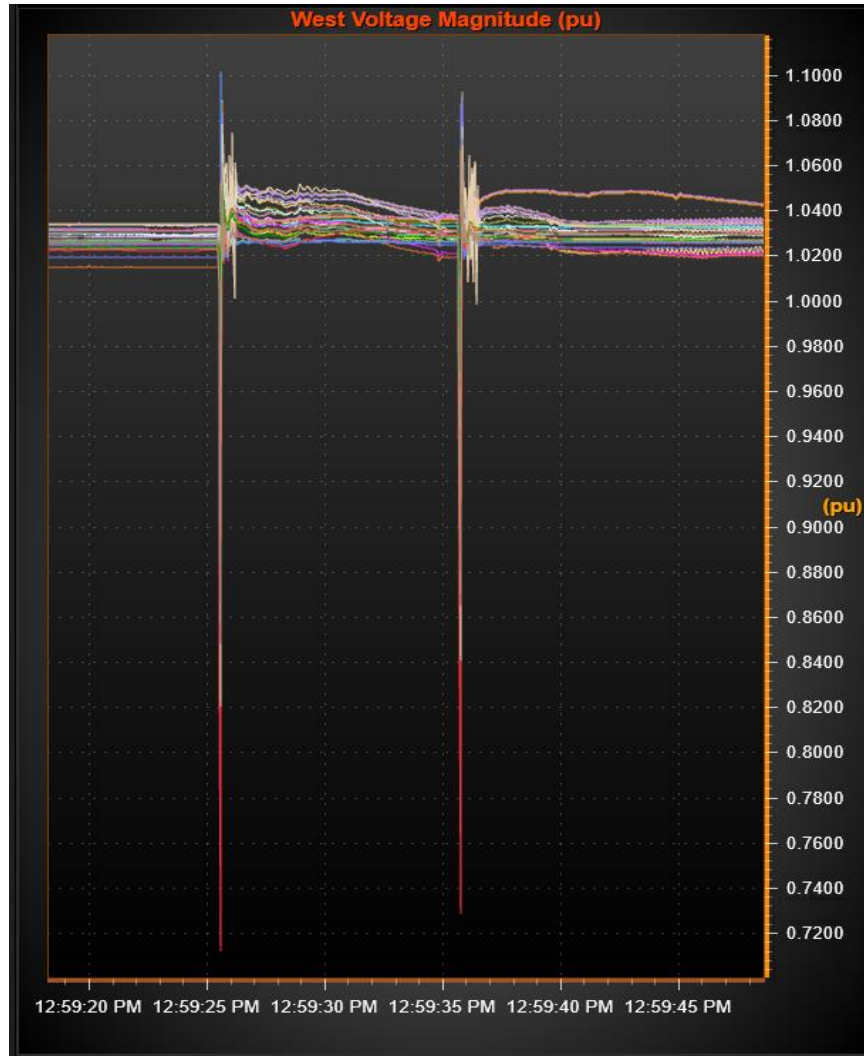
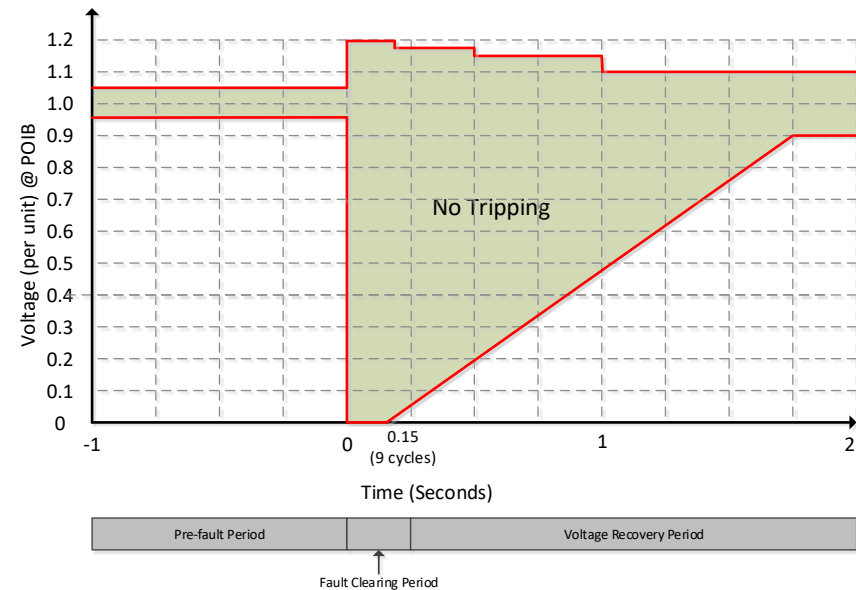
# Real Time PMU Voltages

- ERCOT has ~200 PMUs streaming real time data
- Lowest recorded voltage of 0.714pu from PMU in Odessa area on 345 kV line
- Highest recorded voltage of 1.102pu from PMU in Del Rio area on 138 kV line
- Fault cleared in ~3 cycles
- Attempted reclose ~10 seconds later
- Within VRT “No Tripping” zone in NOG 2.9.1

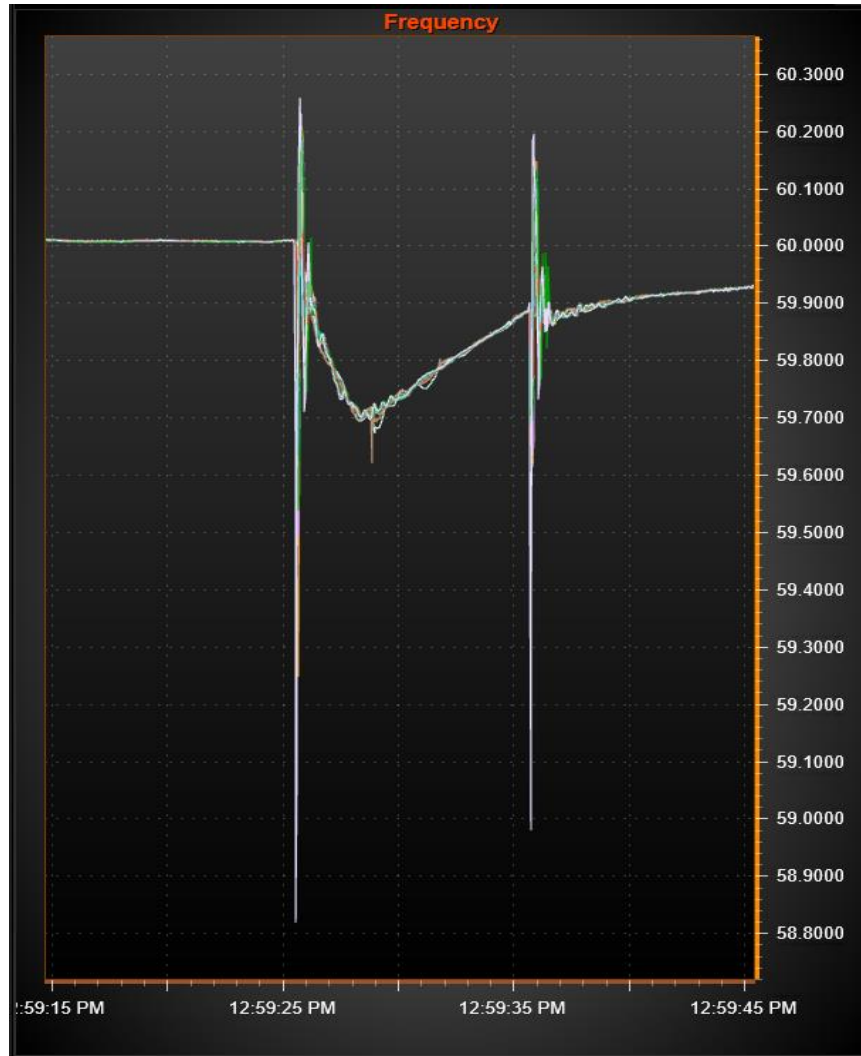
# Real Time PMU Frequency

- Most PMUs lowest freq. of 59.7 Hz after loss of generation
- Single PMU near Laredo had lowest freq. of 59.62 Hz
- Couple other PMUs in South Texas dipped below 59.7 Hz
- Local frequencies during fault conditions measured as low 58.83 Hz and high as 60.26 Hz in Far West Texas
- Protection settings should measure frequencies over >5 cycles to prevent unnecessary tripping

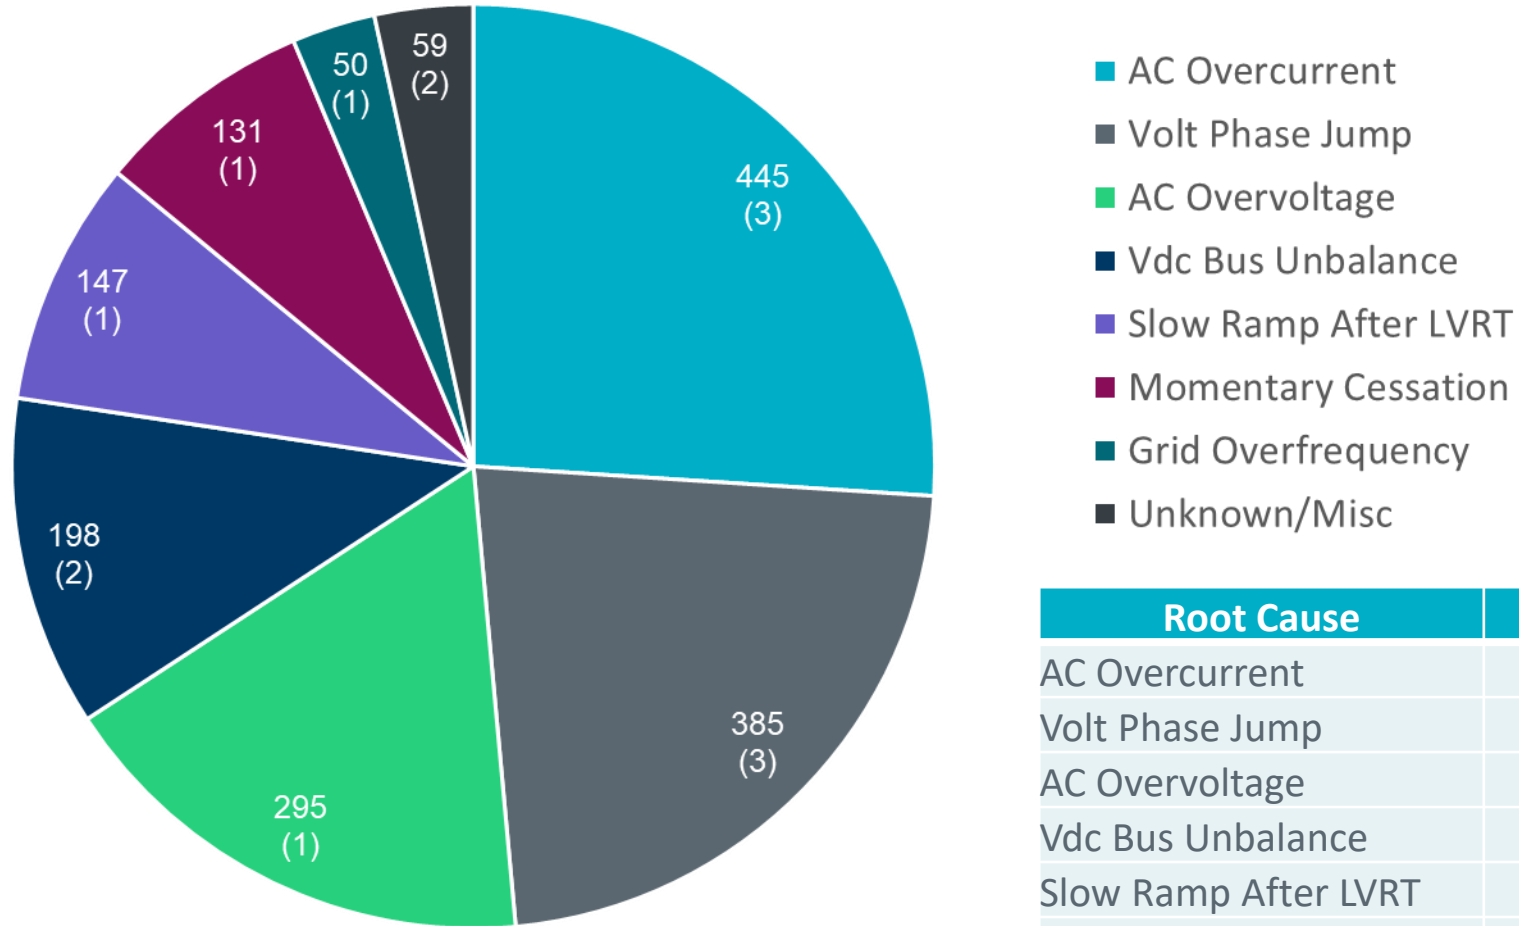
MW Loss by Root Cause

Root Cause	# Affected Facilities	MW Loss
AC Overcurrent	3	445
Volt Phase Jump	3	385
AC Overvoltage	1	295
Vdc Bus Unbalance	2	198
Slow Ramp After LVRT	1	147
Momentary Cessation	1	131
Grid Overfrequency	1	50
Unknown/Misc	2	59
